AmeriSpec Home Inspections

Property Inspection Report

**123 Main St.
Anywhere, USA**

Date: 01/01/2010
Inspection # 123456789
Client Name John Doe
Address Anywhere, USA

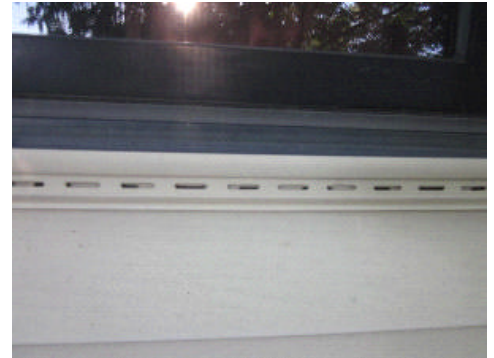
- 101 SIDING
- 102 CONDITION
- 103 TRIM
- 104 Condition

Vinyl.
 Gap noted in the siding at the upper right front corner of the home.
 Repair as needed.
 Vinyl.
 Missing trim noted under the front window. Repair as needed.

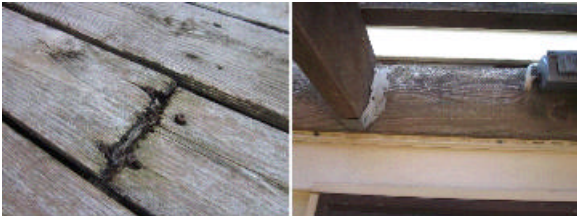
156 DECKS:

Access to deck underside is blocked. No viewing was possible. Footings are not visible and not inspected. Several deteriorated/moisture damaged deck boards noted. The ledger for the deck overhang is not properly secured to the home/flashed. Suggest further review and repairs as needed by a qualified contractor.

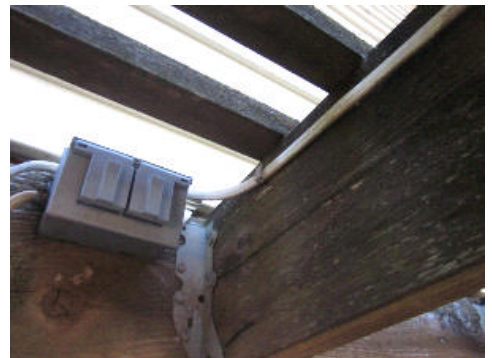
158 ELECTRICAL:

SAFETY CONCERN Loose hanging or otherwise exposed wires noted. Wiring must be properly secured and protected from damage. Recommend securing. Loose outlet noted. **REPAIR** as needed by qualified electrician

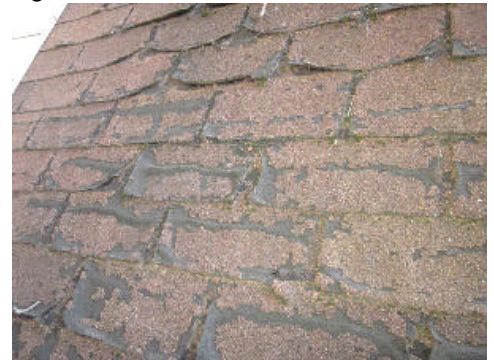
233 ROOF COVERING STATUS:

Roof shows signs of significant granular loss, curling. Areas of damaged/missing shingles noted with exposed sheathing noted. Roof is at the end of its useful life. Suggest further review and repairs/replacement by a qualified roofer.

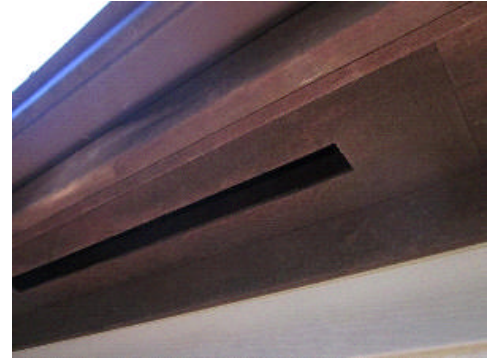
307 Overhangs

Missing screens noted at the vents. Suggest installing.

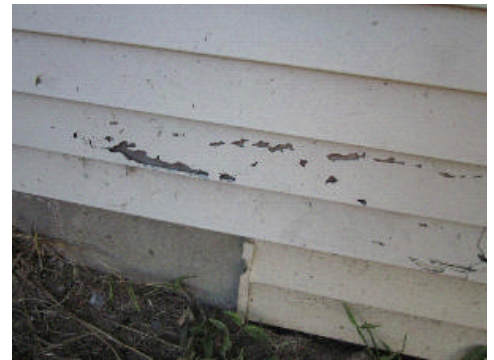
311 TRIM

Vinyl. Loose/damaged trim noted at the left rear corner of the garage. Repair as needed.

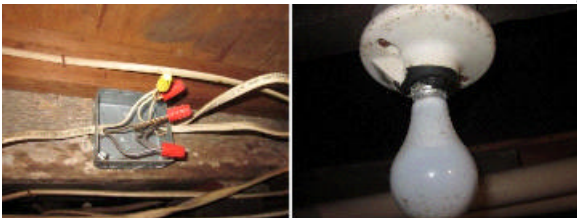
409 FLOOR JOISTS:
410 SUBFLOOR:
411 SUPPORT POSTS:
412 BEAMS:
413 WINDOWS:
414 ELECTRICAL:

SAFETY CONCERN Several open junction boxes noted. Whenever a wire is cut and re-connected, the "splice" should be encased in a covered junction box to prevent shocks and separation of the splice. SAFETY CONCERN Open wiring splices noted. ANY TIME WIRES ARE CONNECTED, THE CONNECTION MUST BE IN A PROPER JUNCTION BOX. Damaged light fixture noted at the floor joist. Repair as needed by qualified electrician.

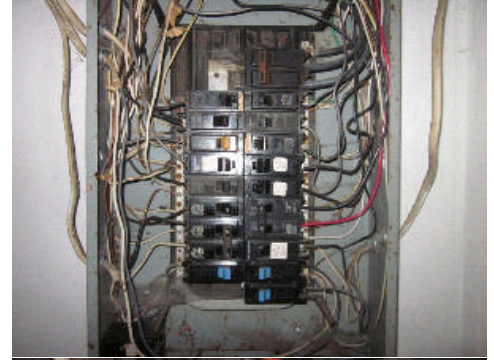
600 MAIN PANEL

Basement left side. The Service Capacity is 100 Amps. 120/240 Volts. Overload protection by breakers. The main conductor is Aluminum, normal for this area. The General-Branch wiring is copper, preferred for safety.

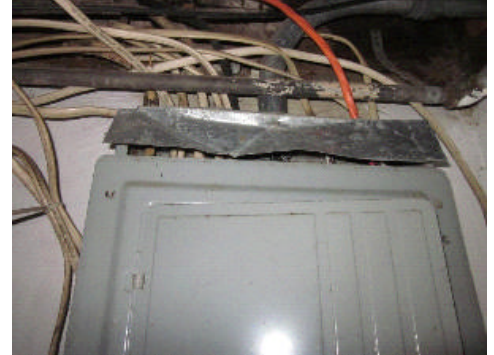
601 CONDITION

Multiple wires are connected to a single lug on a circuit breaker where only one wire should be connected. Suggest further review and repairs as needed by licensed electrician, SAFETY CONCERN Over fusing at main panel. (fuse or breaker size too large for wire size) WIRE SIZES dictate breaker size. Suggest further review and repairs as needed by licensed electrician. The panel cover is not original to this panel is not properly installed/secured. Suggest repairs as needed by a licensed electrician.

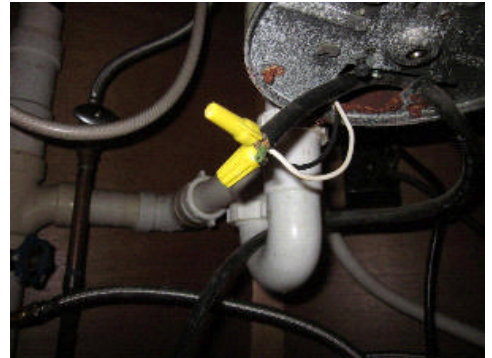
SAFETY CONCERN Open wiring splices noted at the disposal. ANY TIME WIRES ARE CONNECTED, THE CONNECTION MUST BE IN A PROPER JUNCTION BOX. Repair as needed by qualified electrician. SAFETY CONCERN ..GFI Outlet is defective, inoperable or wired incorrectly Repair as needed. Cover plates missing.
